Background and Purpose of Condition Assessment

The intent of this condition assessment is to independently evaluate the condition of Going-to-the-Sun Road. This assessment includes both a review of what had previously been investigated, concluded, and recommended regarding the condition of the Road, and two independent field reconnaissance missions, one in the fall of 2000 and one in early summer 2001.

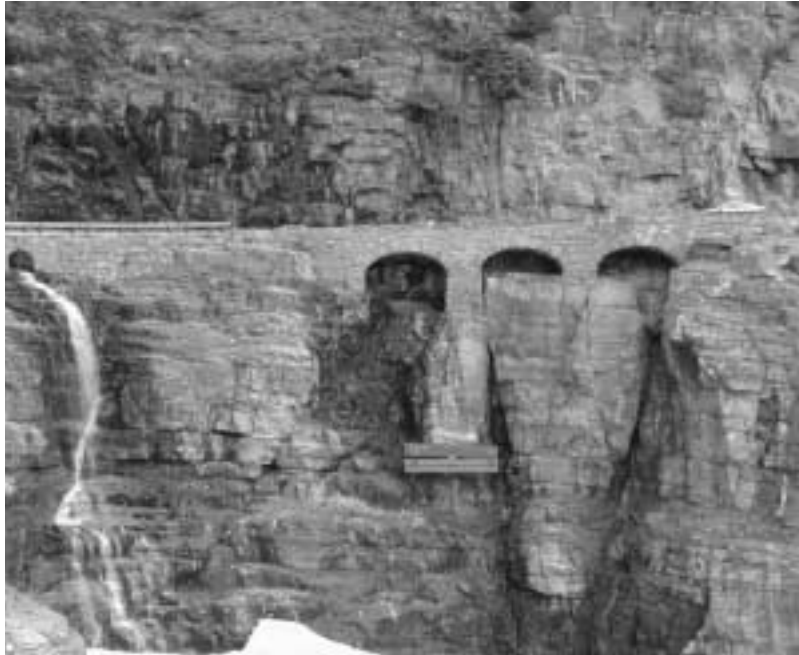
Figure 19: Triple Arches

- **Dry Stack Retaining Walls.** Generally, the dry stack retaining walls were in good condition and functional, with the notable exception of the Loop retaining wall, which is currently under rehabilitation by FHWA.
- **Stone Arches.** Most of the stone arches along the Road are in good condition except for minor to moderate mortar deterioration and weathering. One notable exception is the Crystal Point Arch which exhibits advanced stages of failure (Figures 17 and 18).
- **Triple Arches.** Deteriorating supports and guardwall sections were observed at Triple Arches (Figure 19). As shown in Figure 20, emergency corrective action has been taken by FHWA to shore up the weakened bearing rock support columns. The repair was undertaken in the late fall and was

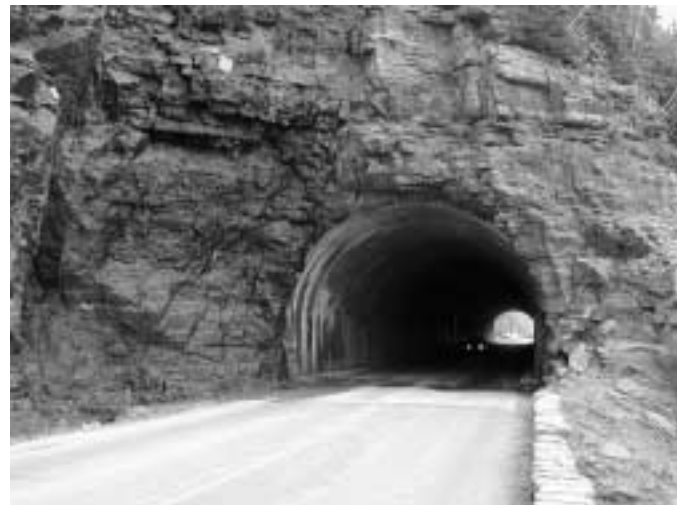
Figure 22: East Tunnel

- **West Tunnel.** No action is needed other than addressing rockfall issues and stone masonry repairs at the east portal and rockfall potential above the window vista near the tunnel's west end. Loose rock should be removed or stabilized in these areas as a safety consideration. Cracks in the tunnel lining appear well healed and are considered benign at this time.
- **East Tunnel.** The tunnel is in good condition and no action is needed at this time. Portal areas should be watched for loose rock, and scaled as appropriate.
